# SEPTICITY ACTION PLAN WANLIP STW

ACTION PLAN TO REDUCED SEPTICITY ON SITE AT WANLIP SEWAGE TREATMENT WORKS, DUE TO THE LACK OF RAINFALL OVER THE PAST 2 TO 3 MONTHS WE HAVE NOTICED HIGHER LEVELS OF ODOUR REPORTED FROM THE SURROUNDING AREA AROUND WANLIP STW, AFTER CARRYING OUT A REACTIVE ODOUR REPORT ON SITE WE HAVE SETUP SOME OVERPUMPING FROM THE OUTFALL OF THE WORKS TO REDUCE THE SECTICITY AROUND SITE TO REDUCE THE ODOUR COMING FROM SITE PAIRED WITH WE HAVE INCREASED CHEMICAL DOSING TO REDUCE THE ODOUR COMING THROUGH THE INCOMING SEWER ON THE NETWORK. ST Classification: UNMARKED

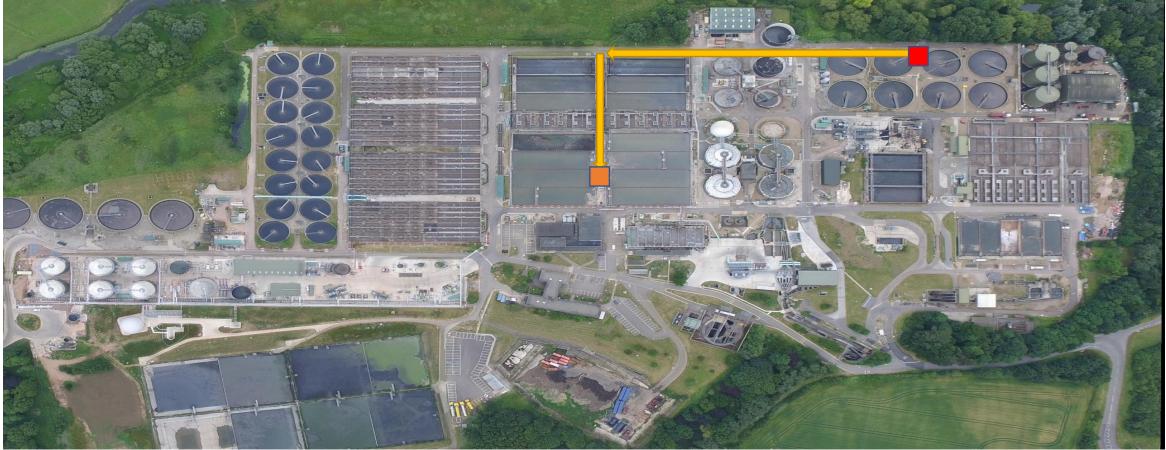
## ROUTE OF OVER PUMPING WANLIP STW

- Location of pumps
- Over pumping discharge point
  - Direction of pumping

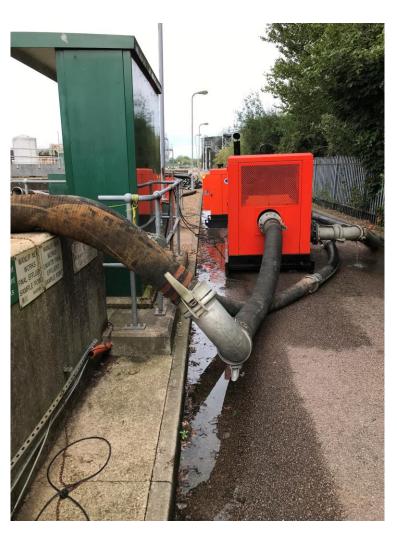
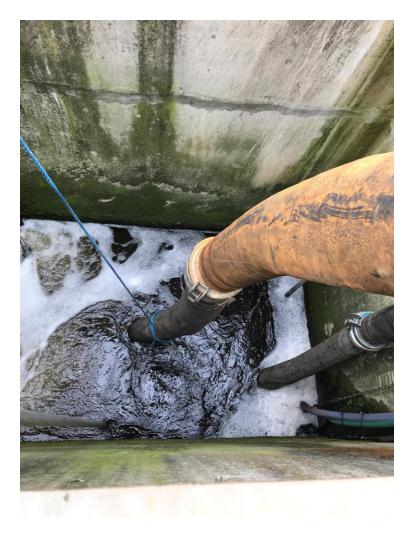
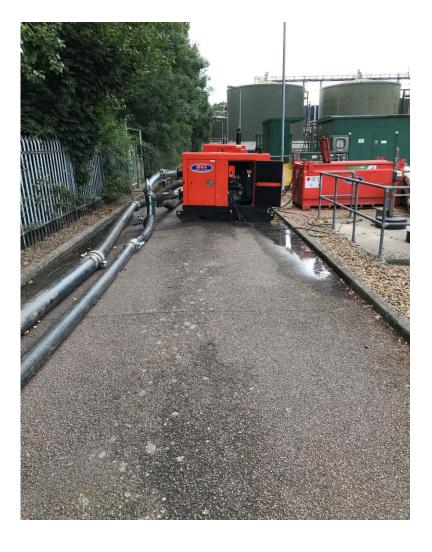
### PUMP SETUP AT THE OUTFALL, FLOWS BEING DRAWN FROM TO ASSIST WITH SEPTICITY AROUND SITE.

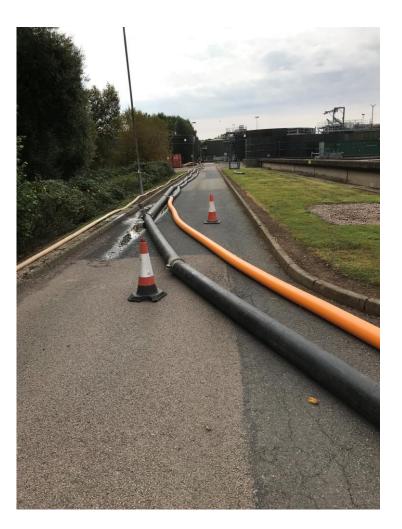
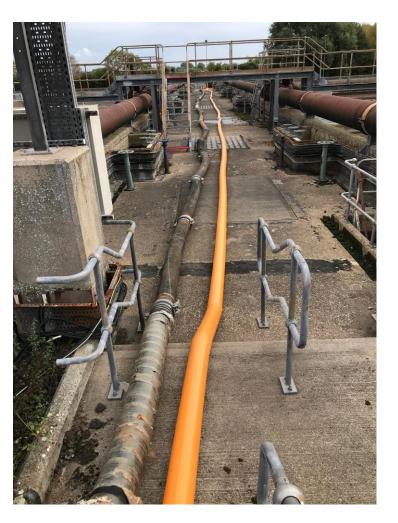
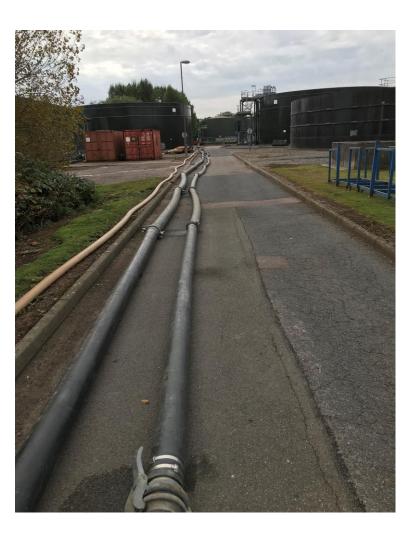
#### LAYOUT OF PIPEWORK ONSITE.

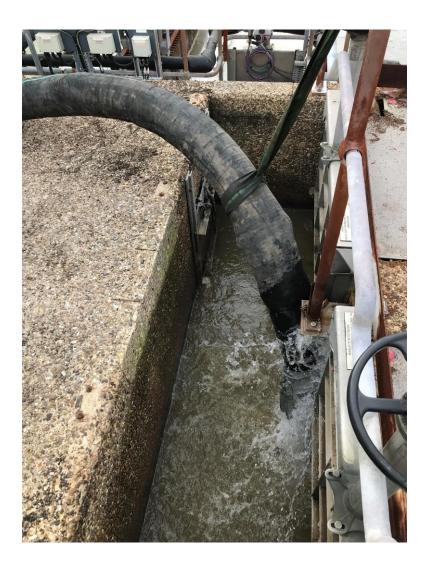
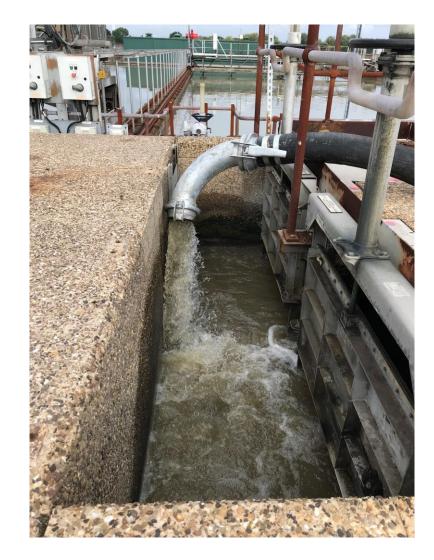
#### DISCHARGE POINTS INTO WORKS AT WANLIP STW
